## MISSOURI - KANSAS CITY RIVER BASIN

TEAL LAKE DAM  
AUDRAIN COUNTY, MISSOURI  
MO. 10082

### PHASE I INSPECTION REPORT NATIONAL DAM SAFETY PROGRAM.

Teal Lake Dam (MO-10082), Missouri - Kansas  
City River Basin. Audrain County, Missouri  
Phase I Inspection Report.

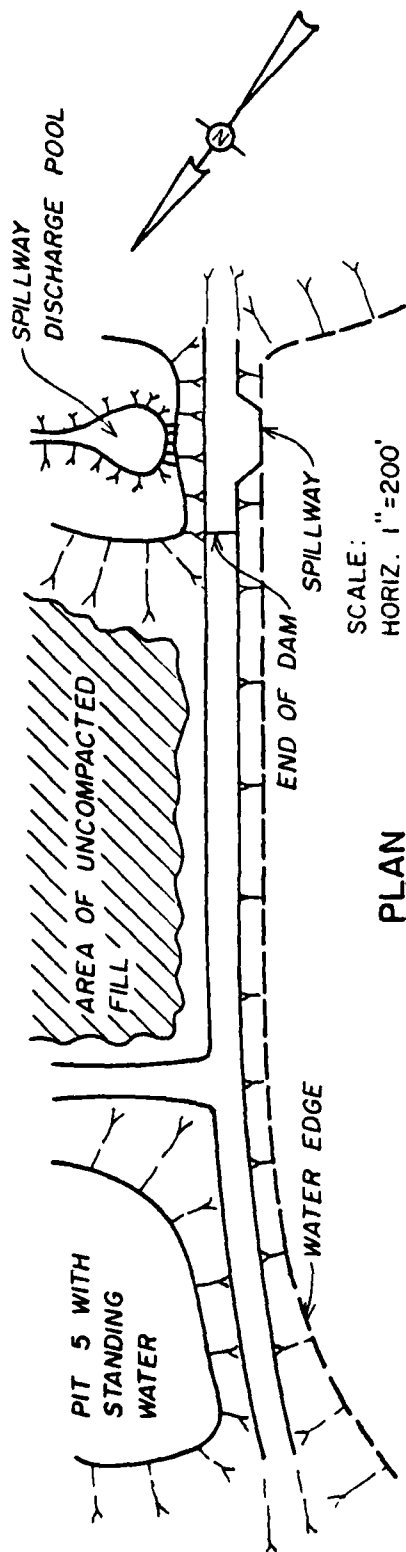
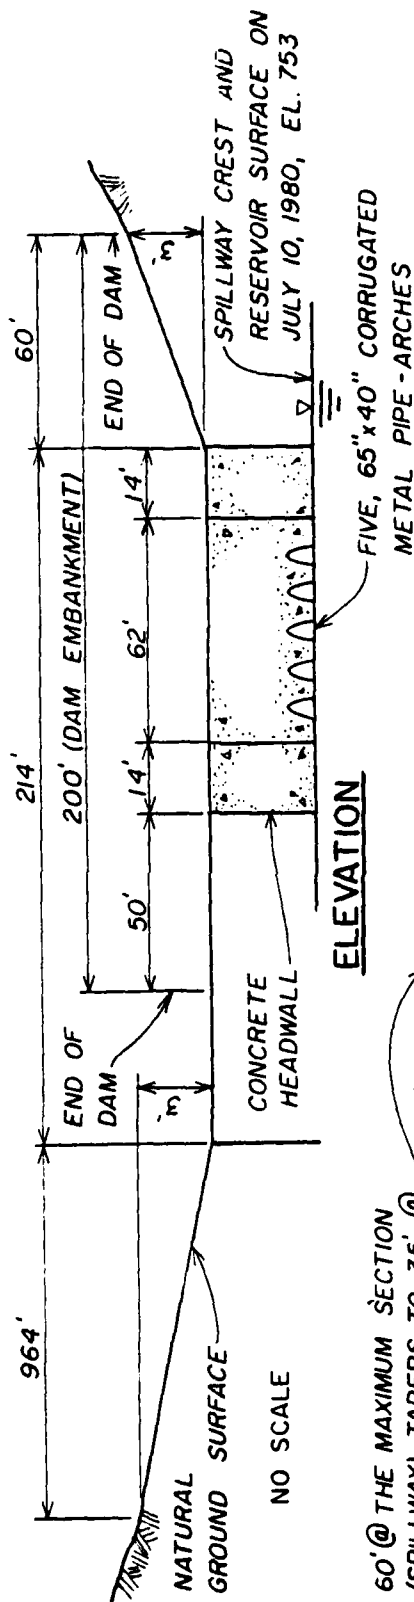
TEAL LAKE DAM (MO. 10082)  
PLAN, ELEVATION &  
MAXIMUM SECTION OF EMBANKMENT

60' @ THE MAXIMUM SECTION (SPILLWAY), TAPERS TO 35' @ EACH END OF SPILLWAY
